Lake Coleridge Project – Coastal processes at Rakaia River mouth

Rakaia River mouth

Martin Single

June 2011

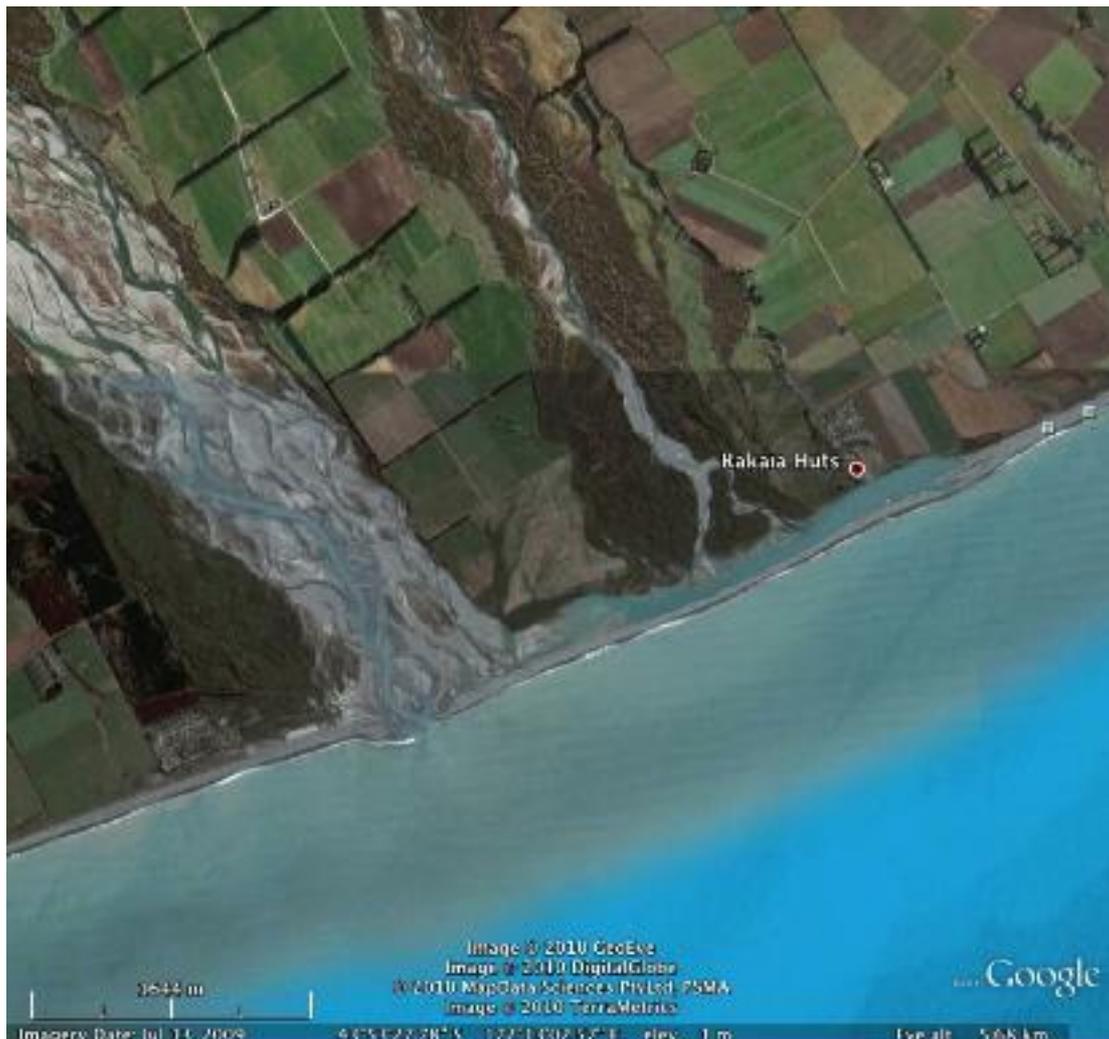
Figure 1 Google Earth image capture of Rakaia Hapua and lower section of Rakaia River

Figure 1 shows the Rakaia River mouth and hapua as of July 2009. The barrier between the sea and the hapua comprises a mixture of sands and gravel. It is generally narrow, and is formed by transport of sediment along the shore by wave swash. The dominant sediment transport is to the north, so the barrier forms as a spit with the southern end wider than the middle and distal end. However, the barrier can also contain a series of inherited features, giving the appearance of overlapping longitudinal ridges.

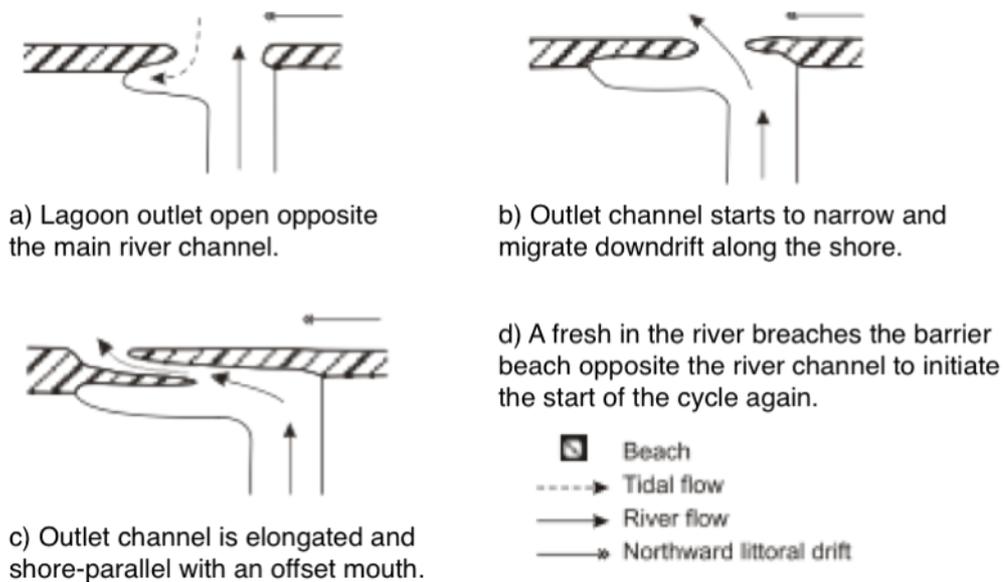
Figure 2 Cycle of river mouth behaviour (after Todd 1992, 212)

The river mouth position and size is controlled by the interaction of river flows with the barrier morphology and marine energy. During floods the barrier is breached opposite the main river channel and flows directly into the sea. During medium to low flow conditions the river outlet can migrate in response to littoral drift of sediments. This results in deflection and elongation of the mouth to the north. This is shown in Figure 2. The position and channel morphology of the outlet changes under these conditions. Under prolonged low flow

conditions it is possible for the mouth to close. The first recorded occurrence for the Rakaia River was in 2010.

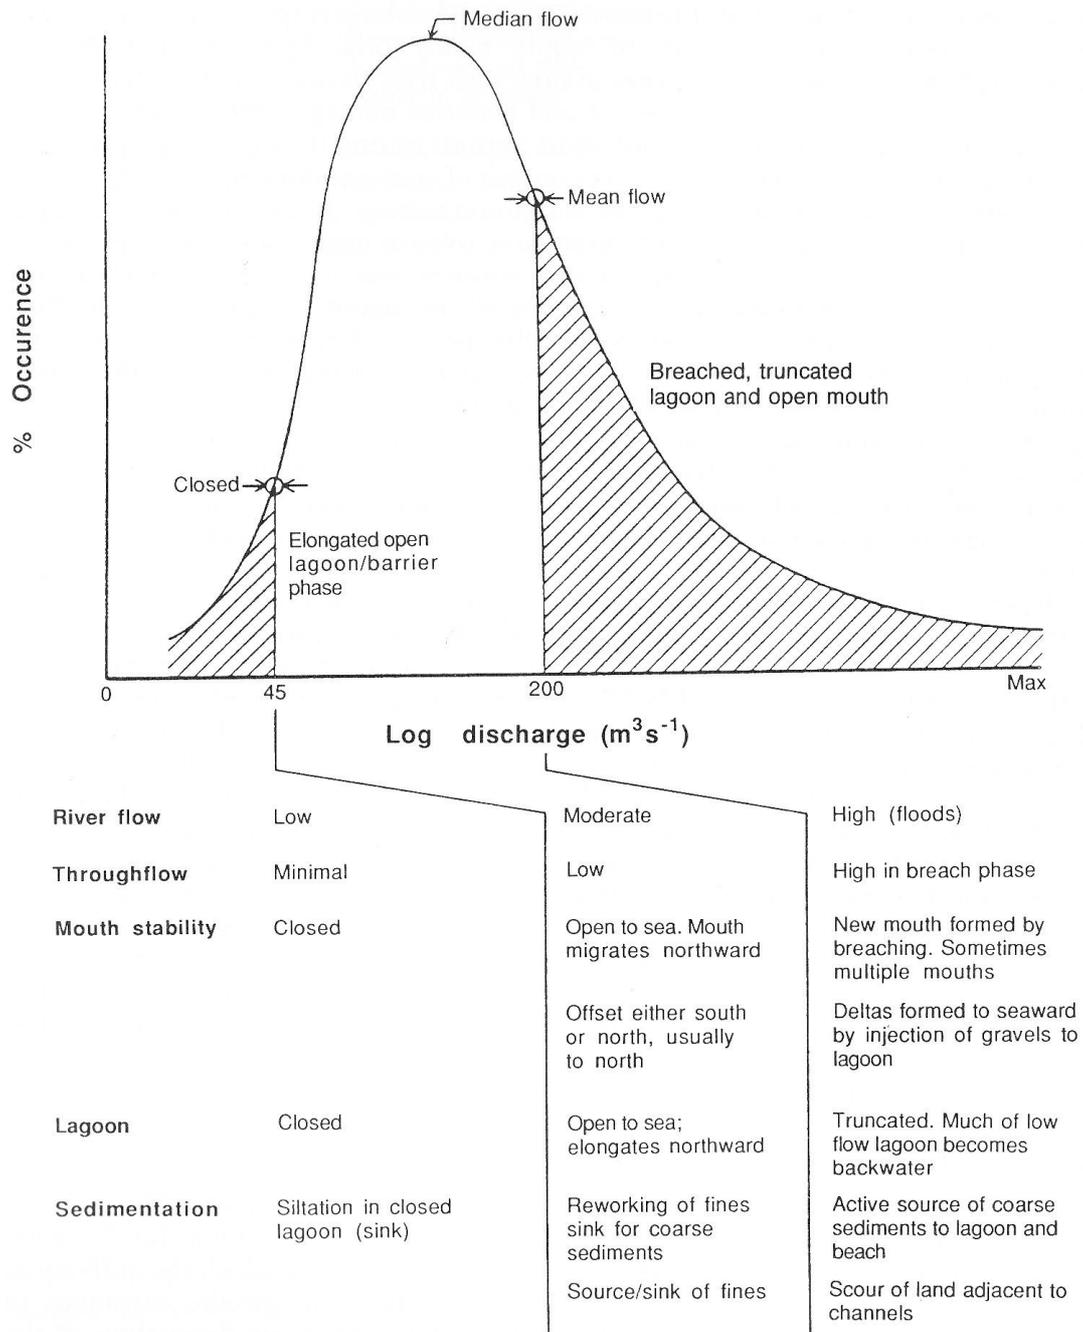
Figure 3 Descriptive model of mixed sand and gravel hapua/spit/barrier processes. Threshold values are set for the Rakaia as functions of river discharge (Source: Kirk 1991, Figure 6).

Kirk (1991) summarised the process relationships and incorporated them into a descriptive model of the Rakaia River mouth system as shown in Figure 3. In this model, at very low river discharges the lagoon is closed to the sea behind an intact barrier, throughflow is minimal and siltation occurs in the lagoon. At more frequent, moderate discharges the lagoon has a single, open, migratory outlet to the sea, throughflow is low, coarse sediments are stored in the lagoon-barrier complex while fines are delivered to the coast. During high-flow, flood conditions the barrier is breached in one or more locations, opening the river mouth directly to the sea and truncating the lagoon while large volumes of sediment are delivered to the adjacent coast. The threshold for such a breach at the Rakaia hapua, $200 \text{ m}^3 \text{ s}^{-1}$, represents the mean annual discharge of this river.

Kirk (1991) developed a model to illustrate the interaction between fluvial and marine processes including sediment transport in the river and along the coast, wave energy and changes in river flows (shown in Figure 3). He found that fluvial processes dominate the river mouth behaviour on the Rakaia River. He noted that development of the water resources of the river has the potential to increase flooding at the river mouth hapua, could cause protracted closure of the mouth and could accentuate coastal erosion.
